Rolf Thunecke
Yacht & Small Craft Surveyor
Diploma Yacht and Small Craft Surveying, IBTC.

Pre-Purchase Survey

Vessel name: xxxxxxxx

Vessel Type: Sailing Yacht

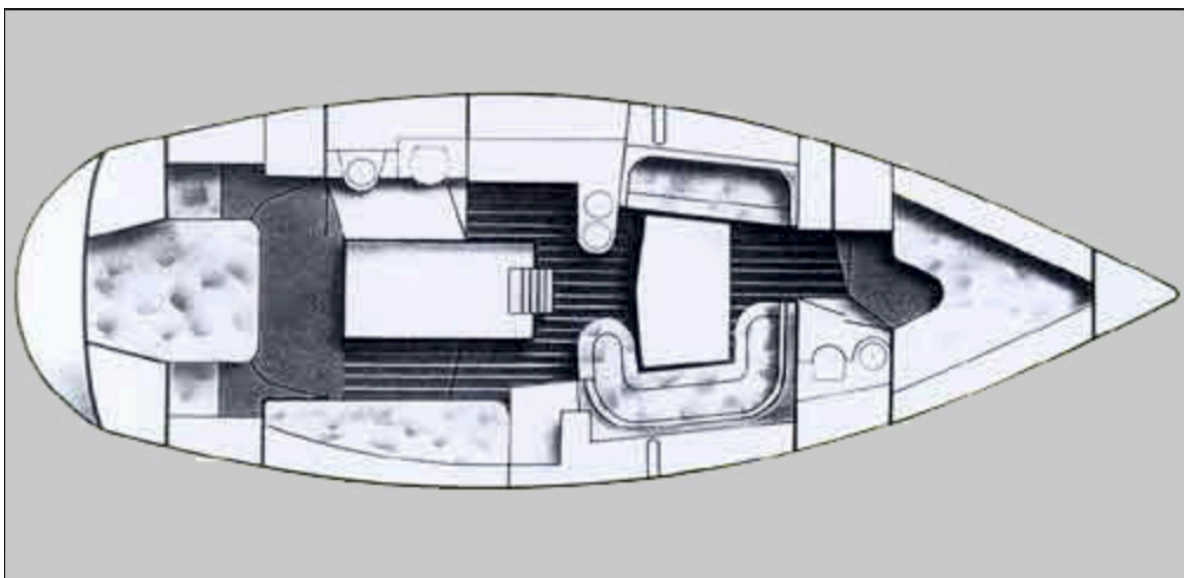
'XXXXXX' was reported as being built in 1995 by Moody. The vessel, which was a highly successful production vessel of the cruising class, was built in the UK. She was a centre cockpit, displacement cruising yacht with a shoal draft keel. The vessel had a sloop rig with alloy mast and boom. The auxiliary engine was a Volvo diesel, with shaft and single propeller. The hull was of moulded GRP finished in white gel coat with blue waterline stripes.
